GRINNELL COLLEGE
FORUM ADA EVALUATION

February 11, 2011

RDG Planning & Design
2712 Stange Road
Ames, IA 50010

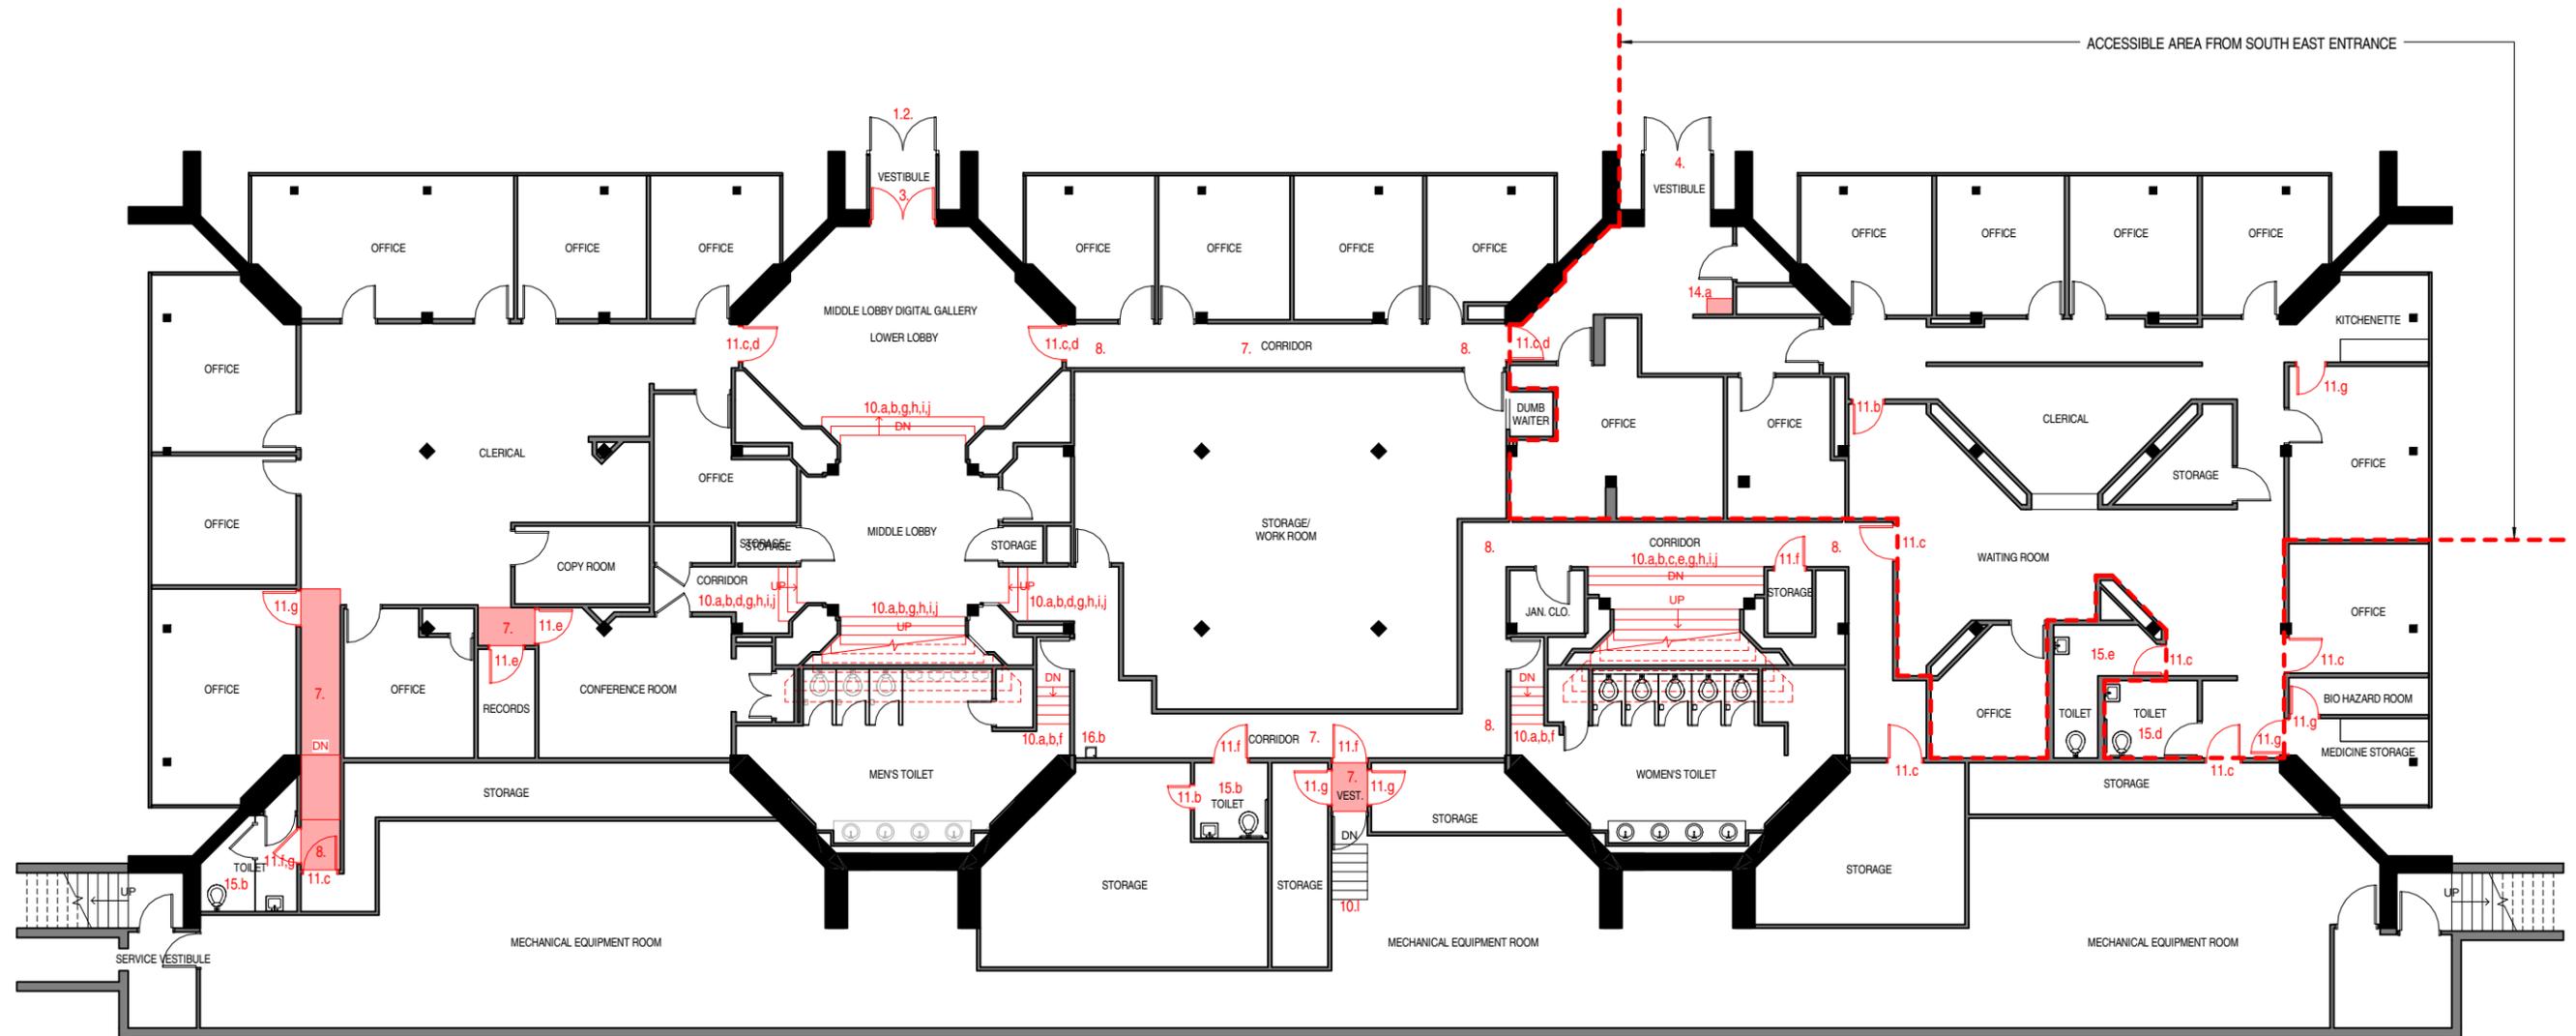
NON-COMPLIANCE EVALUATION – EXISTING LOWER LEVEL PLAN

The following components do not comply with the Americans with Disabilities Act Accessibilities Guideline of 2010. The locations for these non-complaint items are keyed to the following floor plan diagrams with corresponding items below. These items are prioritized in accordance with the *ADA Checklist for Existing Facilities version 2.1* from the highest to the lowest.

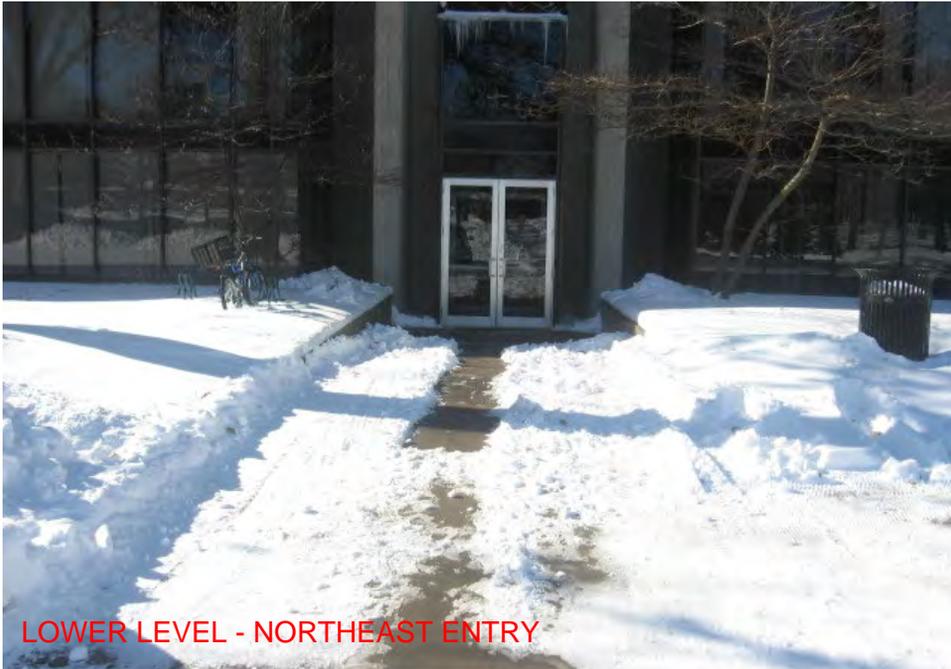
LOWER LEVEL - NORTHEAST ENTRY

3. Vestibule Entrances – Lower Level Northeast & Upper Level, Main West Entries:
 - a. Require a 7' minimum distance between the vestibule doors.
ADAAG: 1998 4.13 & 2010 404

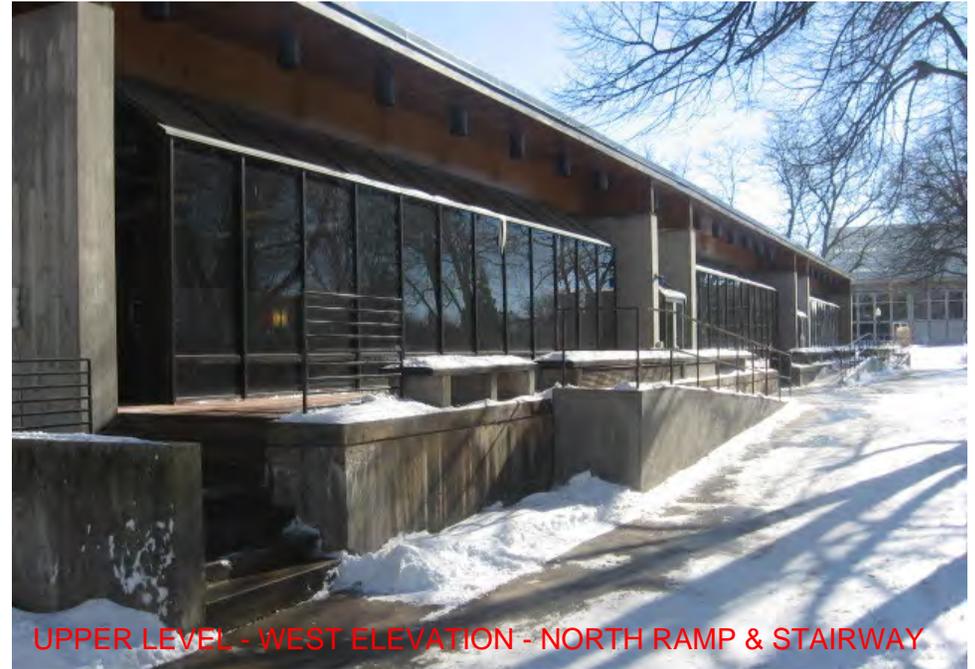
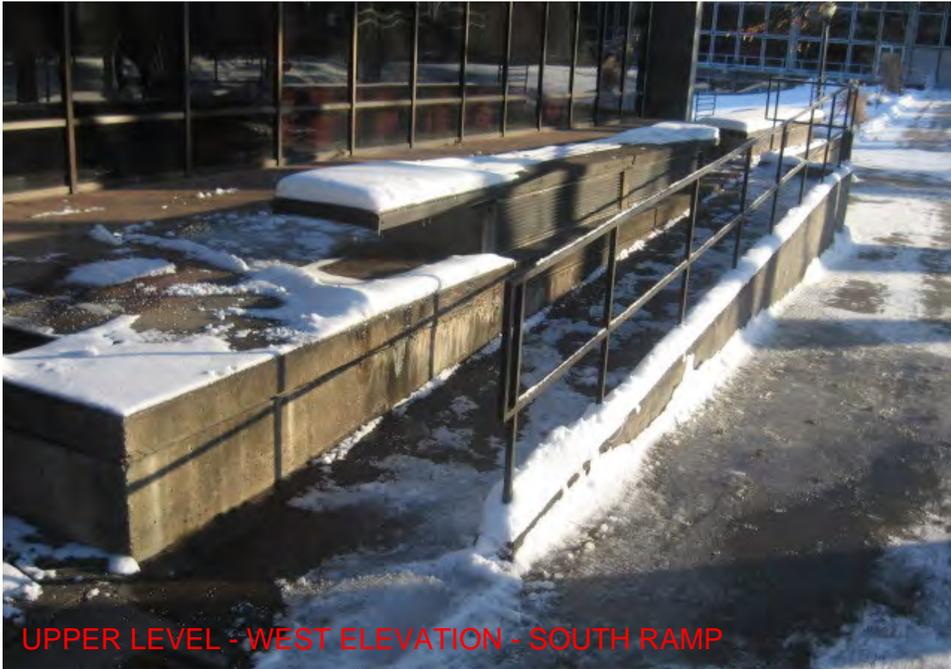
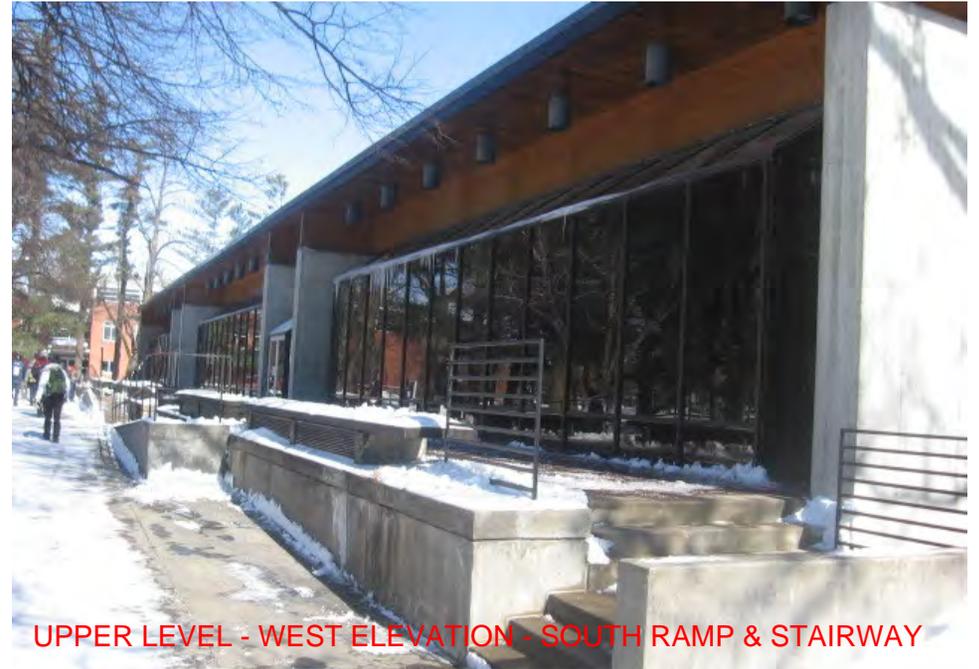
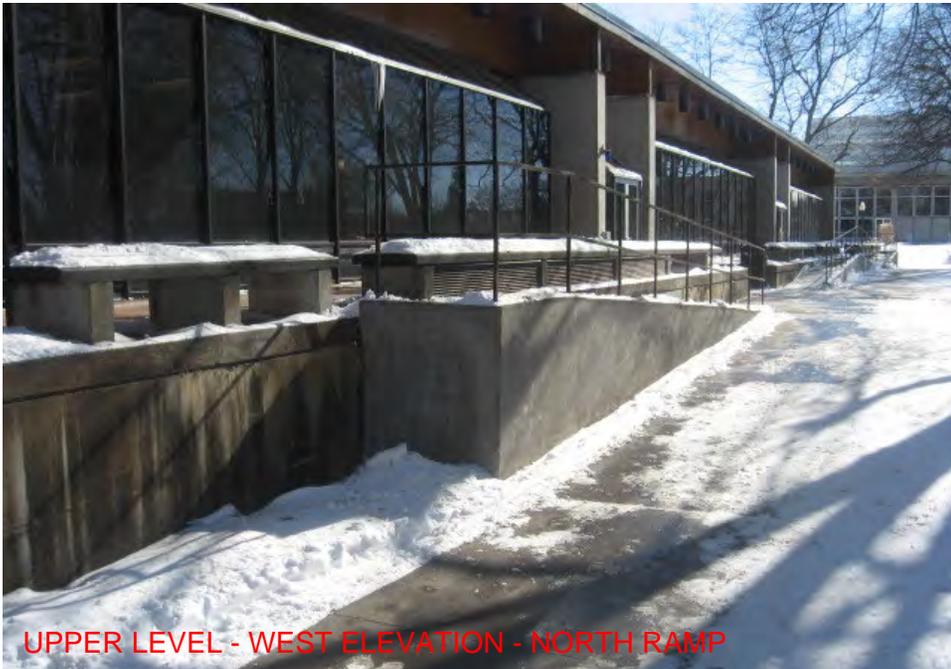
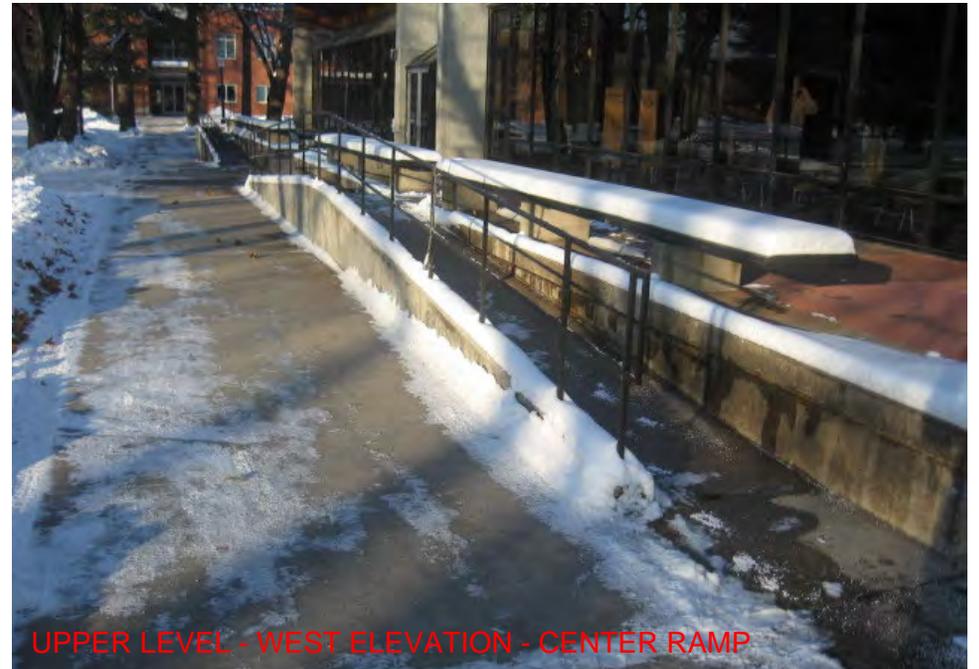
5. West Ramps: These ramps are non-compliant.
 - a. Handrails are required on both sides of these ramps.
ADAAG: 1998 4.8 & 2010 405, 505
 - b. Handrails do not have the 12" minimum extension at the bottom of the ramps.
ADAAG: 4.8 & 2010 505
 - c. It was observed that the north and south ramps have a 1" and 2" vertical transition from the top of the ramp landing to the terrace levels. No transition is allowed at these locations.
ADAAG: 1998 4.5 & 2010 303
 - d. The top landings are also to be 60" long. The current landings vary from 36" to 48" in length.
ADAAG: 1998 4.8 & 2010 405
 - e. It is also noted that location over 30" in height require guardrails that will not allow a 4" sphere to pass per building code.

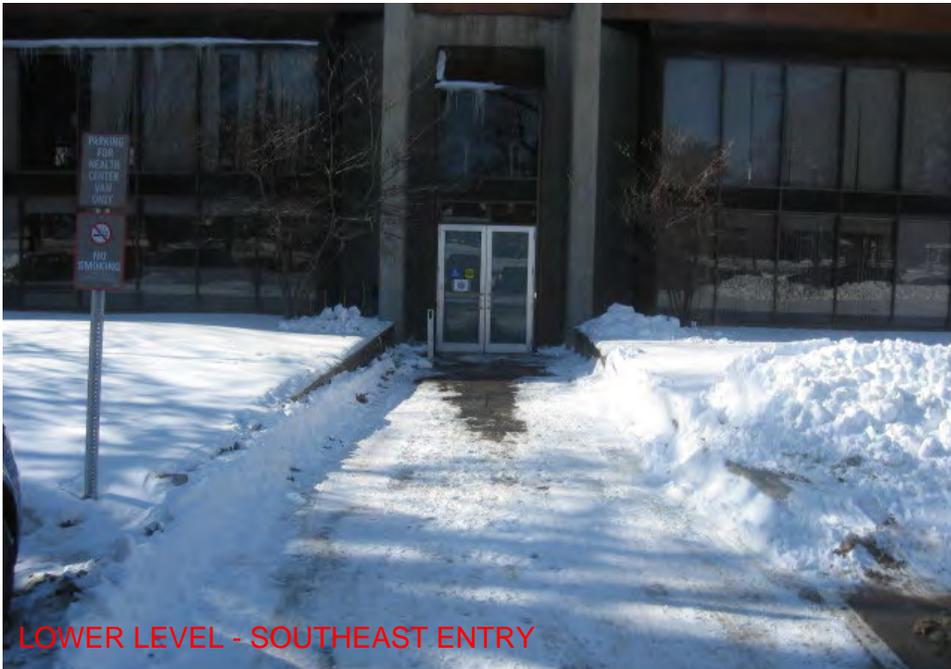
LOWER LEVEL - SOUTHEAST ENTRY

4. Lower Level – Southeast Entry: This is the only fully compliant accessible entrance for the building. Accessibility may be limited when this entrance is used for service delivery, however this is acceptable.
ADAAG: 1998 4.1 & 2010 206

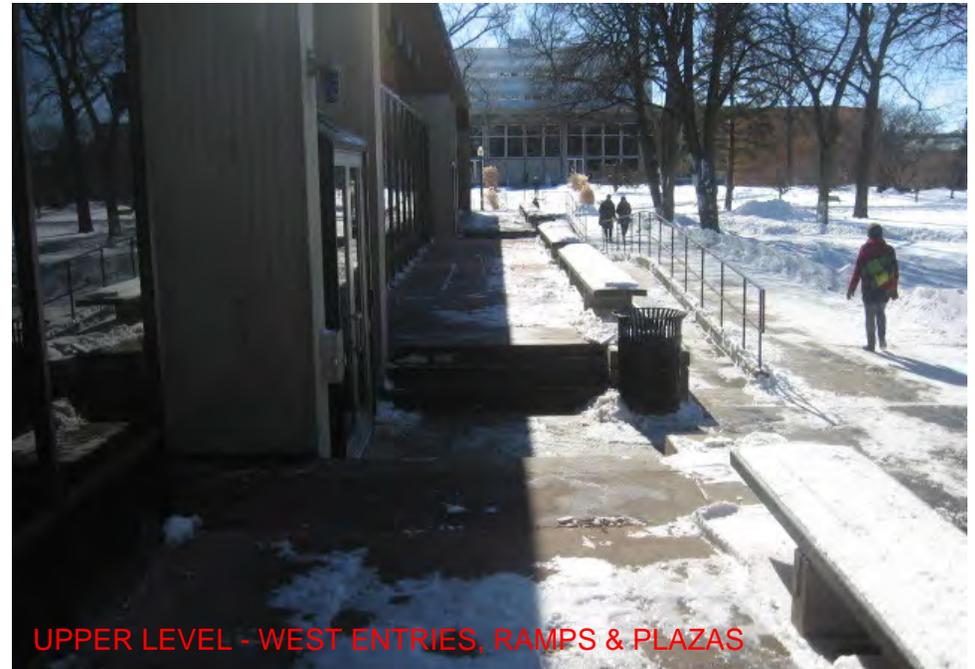
UPPER LEVEL - WEST ENTRIES, RAMPS & PLAZAS

6. Terrace West Entries: The original doors do not provide adequate clearance to function as accessible entrances. Side approach to pull doors with closures require 54" clear perpendicular to the door.
ADAAG: 1998 4.13 & 2010 404

The new door that was added is not accessible as an entry door as the ramps to it are non-compliant.

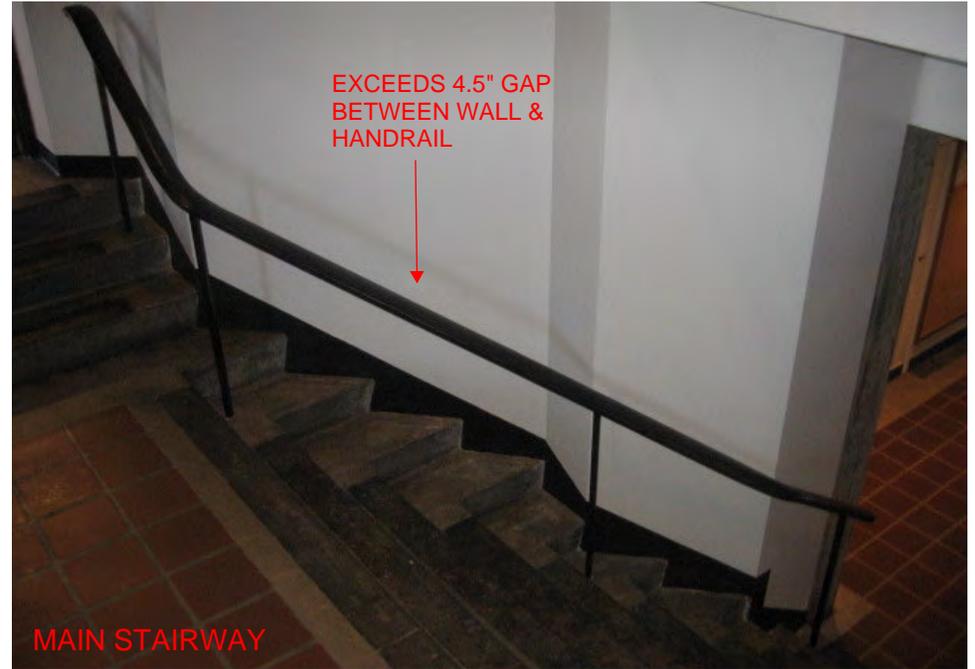
MAIN STAIRWAY

- h. Handrail grasping surfaces exceed the non-circular perimeter measurement of 6 ¼" maximum and a cross-section of 2 ¼" maximum.
ADAAG: 2010 505
- i. Handrails shall also not protrude more than 4.5" from walls.
ADAAG: 2010 307, 405

EXCEEDS 4.5" GAP
BETWEEN WALL &
HANDRAIL

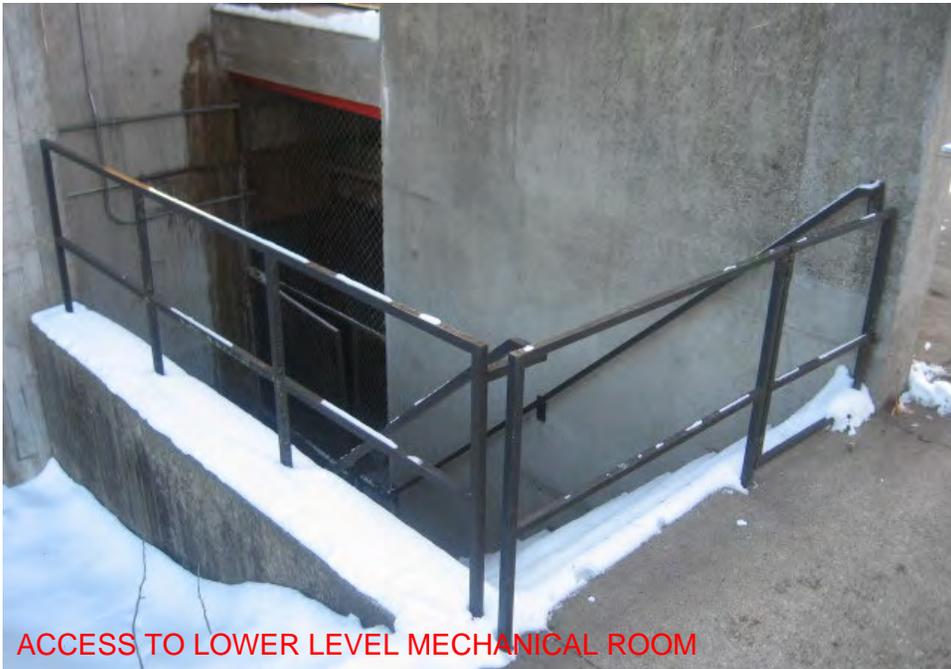
ACCESS TO LOWER LEVEL MECHANICAL ROOM

- l. The mechanical rooms on the lowest part of the building are not required to be accessible.
ADAAG: 1998 4.1 & 2010 203.

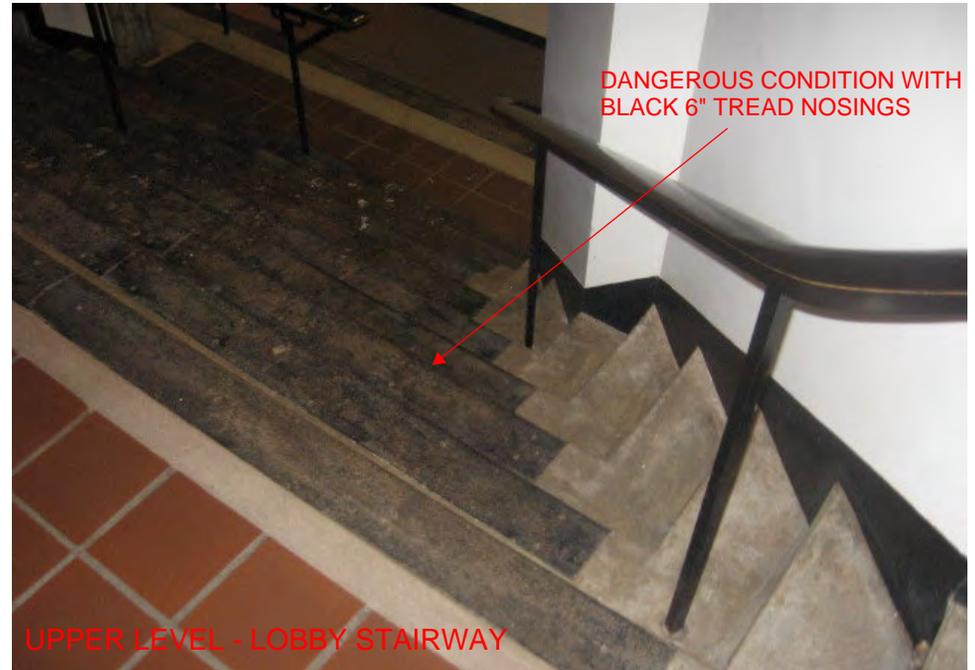
UPPER LEVEL - LOBBY STAIRWAY

- b. The black 6" wide stair tread nosings do not provide enough visual contrast to the individual steps which create dangerous conditions. (See appendix for pictures). It is recommended that the tread nosing be a depth of 1 to 2 inches. The leading edge of treads should contrast in color with the rest of the treads to increase visibility.
ADAAG: 2010 504

DANGEROUS CONDITION WITH
BLACK 6" TREAD NOSINGS
