GRINNELL COLLEGE
FORUM ADA EVALUATION

February 11, 2011

RDG Planning & Design
2712 Stange Road
Ames, IA 50010

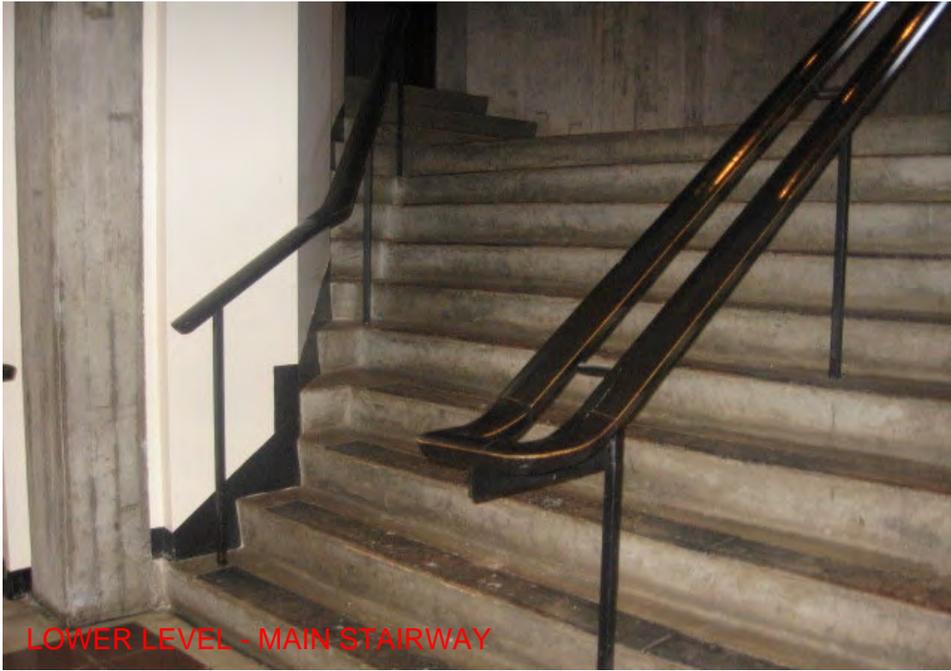
LOWER LEVEL - MAIN STAIRWAY

- b. The black 6" wide stair tread nosings do not provide enough visual contrast to the individual steps which create dangerous conditions. (See appendix for pictures). It is recommended that the tread nosing be a depth of 1 to 2 inches. The leading edge of treads should contrast in color with the rest of the treads to increase visibility.
ADAAG: 2010 504

DANGEROUS CONDITION WITH
BLACK 6" TREAD NOSINGS

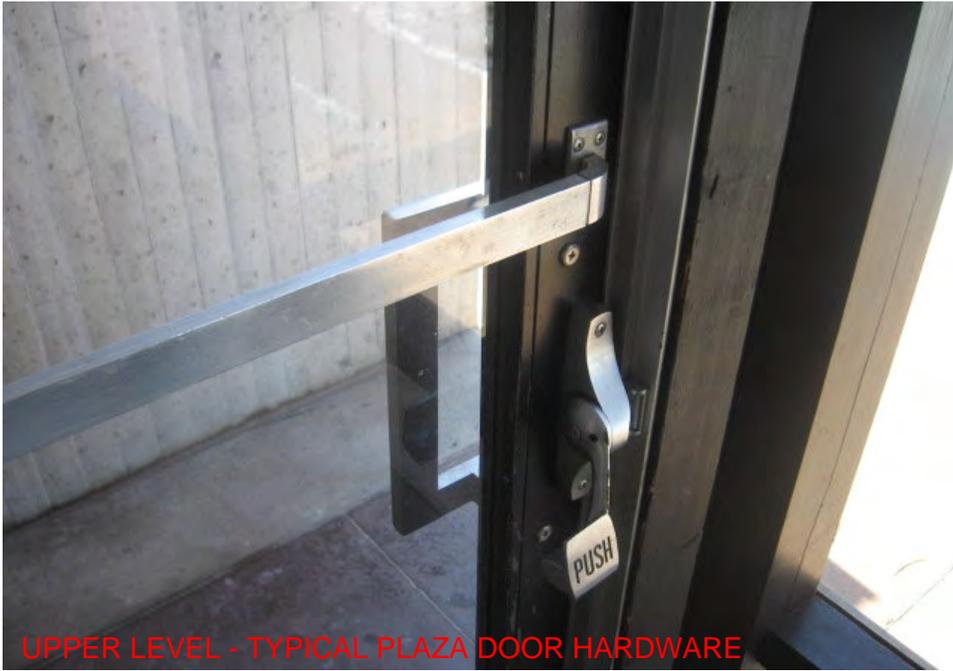
UPPER LEVEL - TYPICAL PLAZA DOOR HARDWARE

- i. Door hardware to have an easy to grasp shape, operable with one hand, and does not require tight grasping or twisting of the wrist. Only a small number of latches that have been updated comply. Because of this, the locations are not noted on the plans.
 ADAAG: 1998 4.13, 4.27 & 2010 404, 309

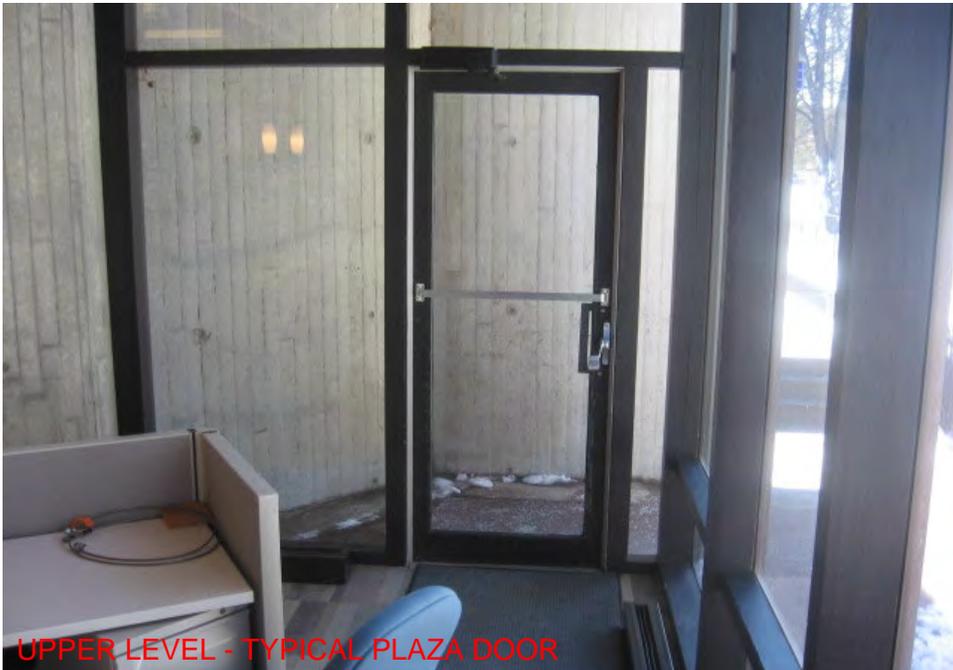
UPPER LEVEL - TYPICAL PLAZA DOOR

- m. It was noted that the existing panic bars do not extend the full width of the door. Though this is not an ADA issue, it may not meet current building code requirements.
